# Manhole Inspection Summary

Manhole # S35SS\_020MH

**Location** Address: **2628 GUILFORD AVE**

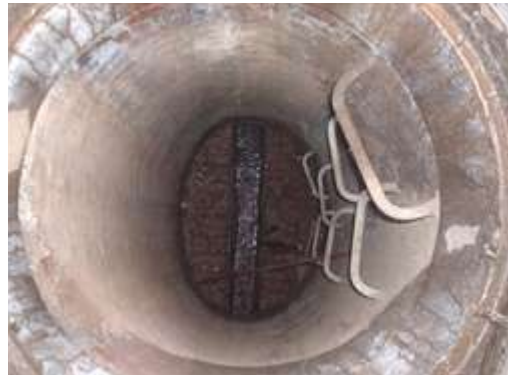
Top View

Frame leaks. Bench debris.

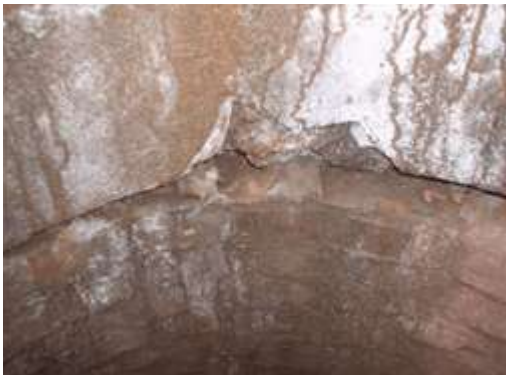
Defect

Frame leaks. Cracked frame. Adjustment deterioration and infiltration.

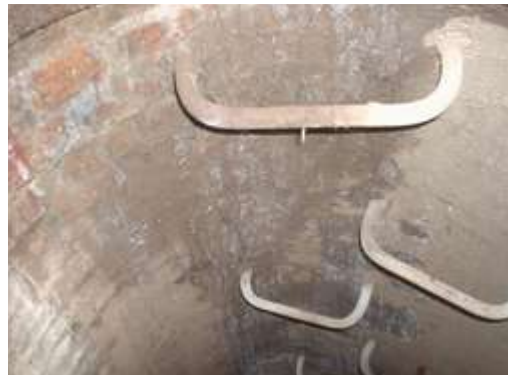
Defect

Adjustment infiltration.

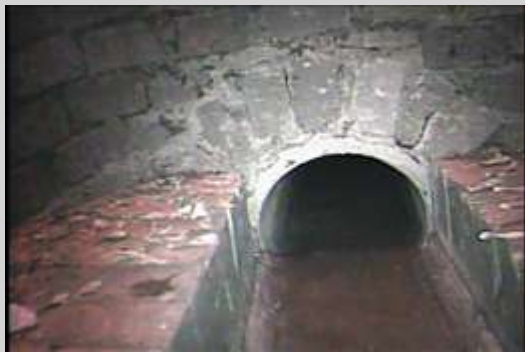
### 8 in. Circular Gravity Sewer Pipe Out @ 12 O'Clock

Channel deterioration.

Infiltration: **None** Pipe Seal Cond: **Cracked**
